HWY-05-M-H035
Wilmer, Texas

Forensic Tire Report - Bridgestone/Firestone

VEHICLE FACTORS: TIRES AND TIRE MARKS

Description: Motorcoach Fire
Location: I-45 Near Wilmer, Dallas Co., Texas
Date: September 23, 2005
NTSB Case No.: HWY-05-MH-035

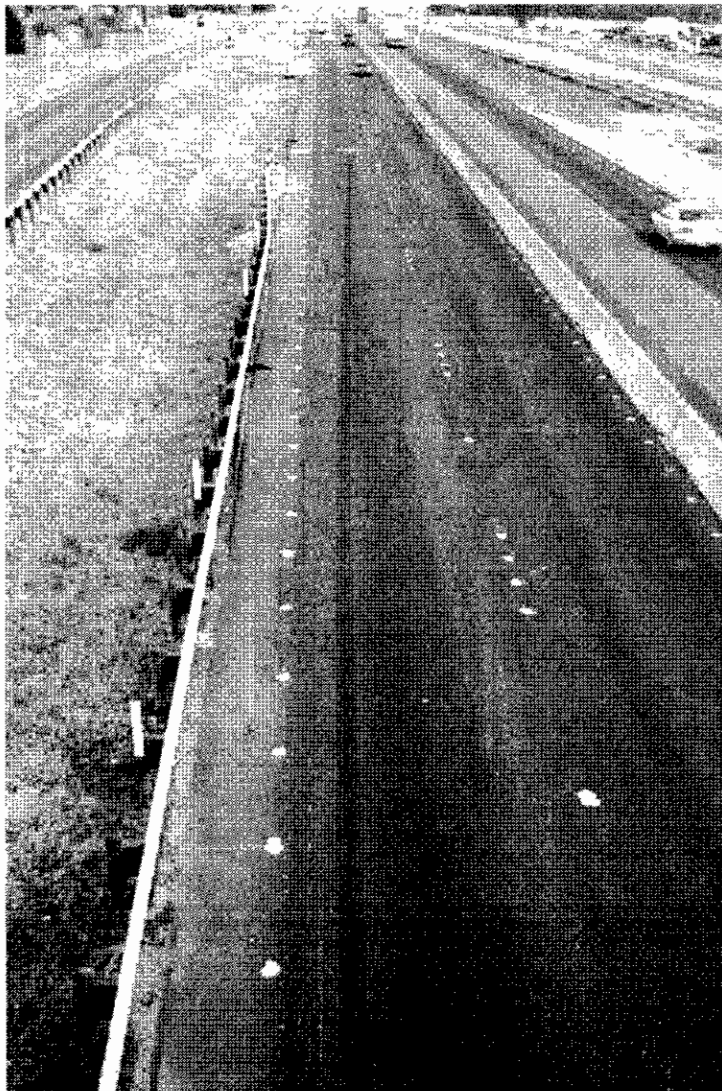
Figure 1: NTSB-092805-008.jpg

2. At the initiation of the lock-up, the skid mark exhibits a distinct appearance of the five tread ribs and is indicative of an inflated tire. The skid mark transitions to a solid appearance and ultimately to a wider appearance composed of numerous essentially parallel marks. The tire became flat an estimated 1,500 feet from the initiation of the lock-up.

Figure 1, a southbound view from the FM 1126 overpass, shows approximately the first 200 feet of the skid mark in the right-most lane of northbound I-45 with the initiation point just north of the exit ramp for Exit 239. In Figures 2 and 3, the five ribs of the tread can be observed in the skid mark.

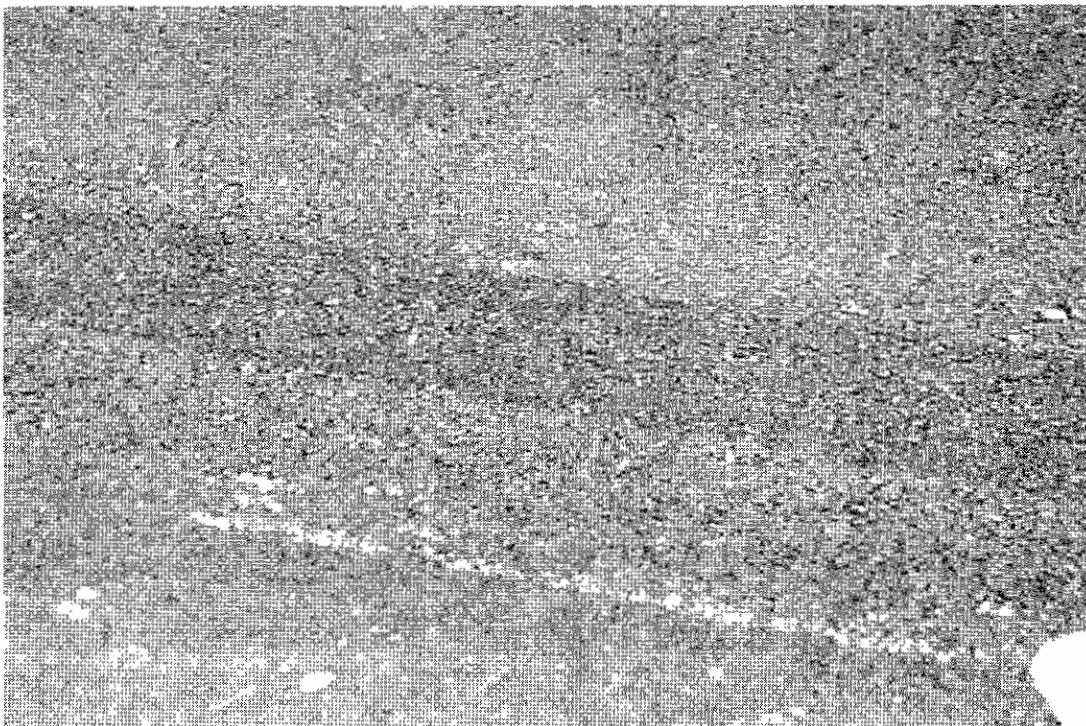
Figure 4: NTSB-092805-018.jpg

Figure 4 shows the skid mark at approximately 1150 feet as essentially a solid mark, absent a distinct tread rib appearance.

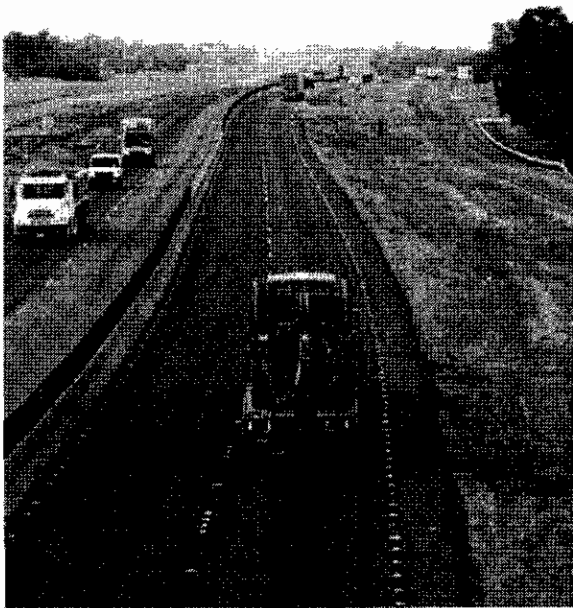
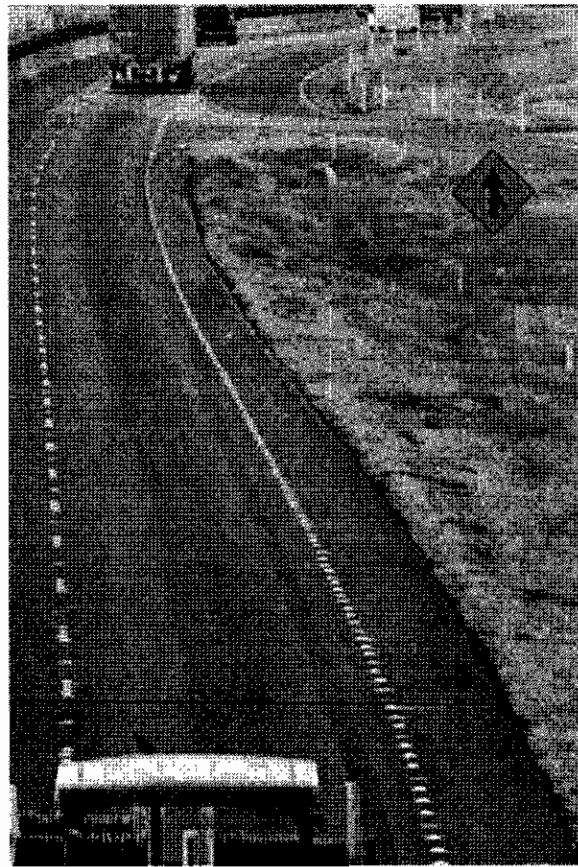
Figure 5: NTSB-092805-014.jpg

Air loss is estimated to have occurred approximately 1500 feet from the initiation of the skid in an area where the solid skid mark transitions to a flat tire appearance between the merging traffic sign and the entrance ramp from the frontage road, as shown in Figures 5 and 6 (a northbound view from the FM 1126 overpass).

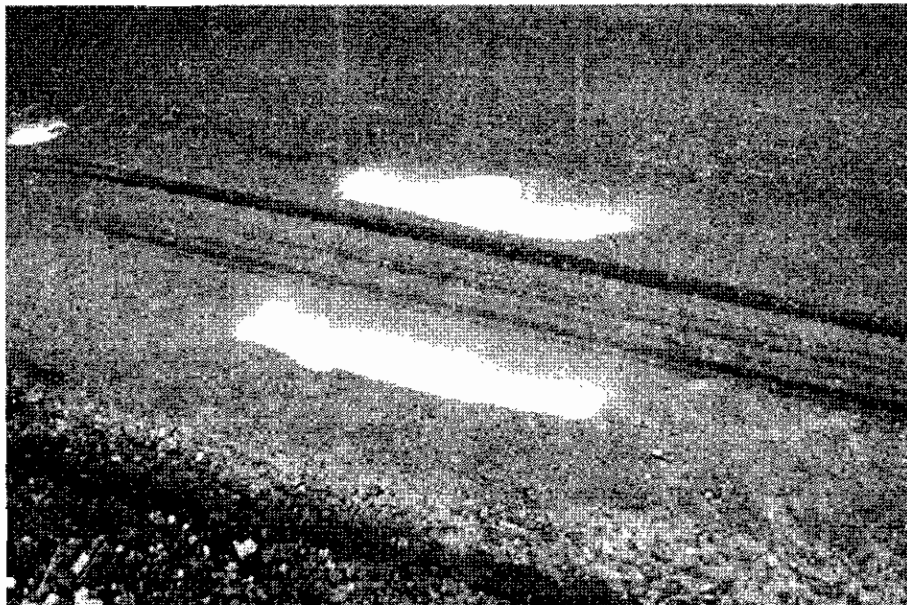
Figure 7: NTSB-092805-023.jpg

A view of the flat tire skid mark at about 1750 feet is shown in Figure 7.

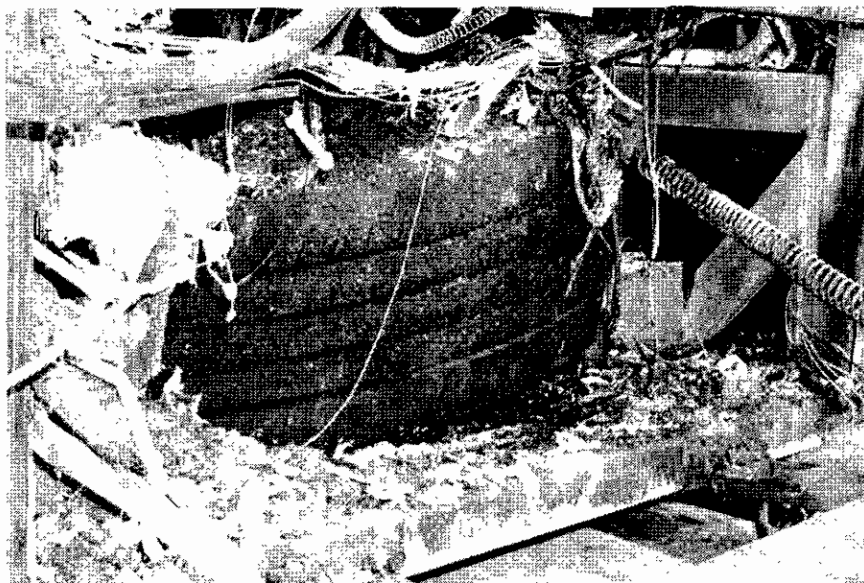
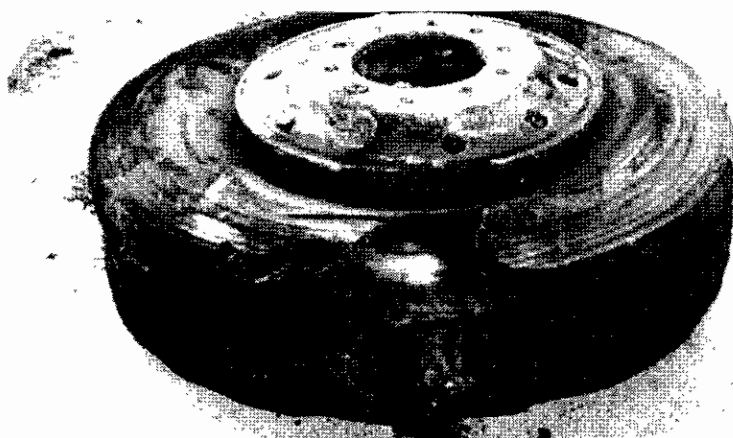
Figure 10: P0001651.jpg

My understanding is that the flat tire and wheel assembly (Subject Tire/Wheel Assembly #1) was removed and exchanged with a spare tire/wheel assembly (Subject Tire/Wheel Assembly #2) by a mobile service. The spare was obtained from the coach's spare tire carrier and the flat tire/wheel assembly was placed into the same carrier, which is horizontally-oriented at the front of the coach. Figure 10 shows Subject Tire/Wheel Assembly #1 prior to removal from the spare tire carrier by investigators. Figure 11 is a photo of the assembly subsequent to removal from the carrier, with a particular view of the tread and outboard sidewall showing the predominant abrasion damage that resulted in air loss.

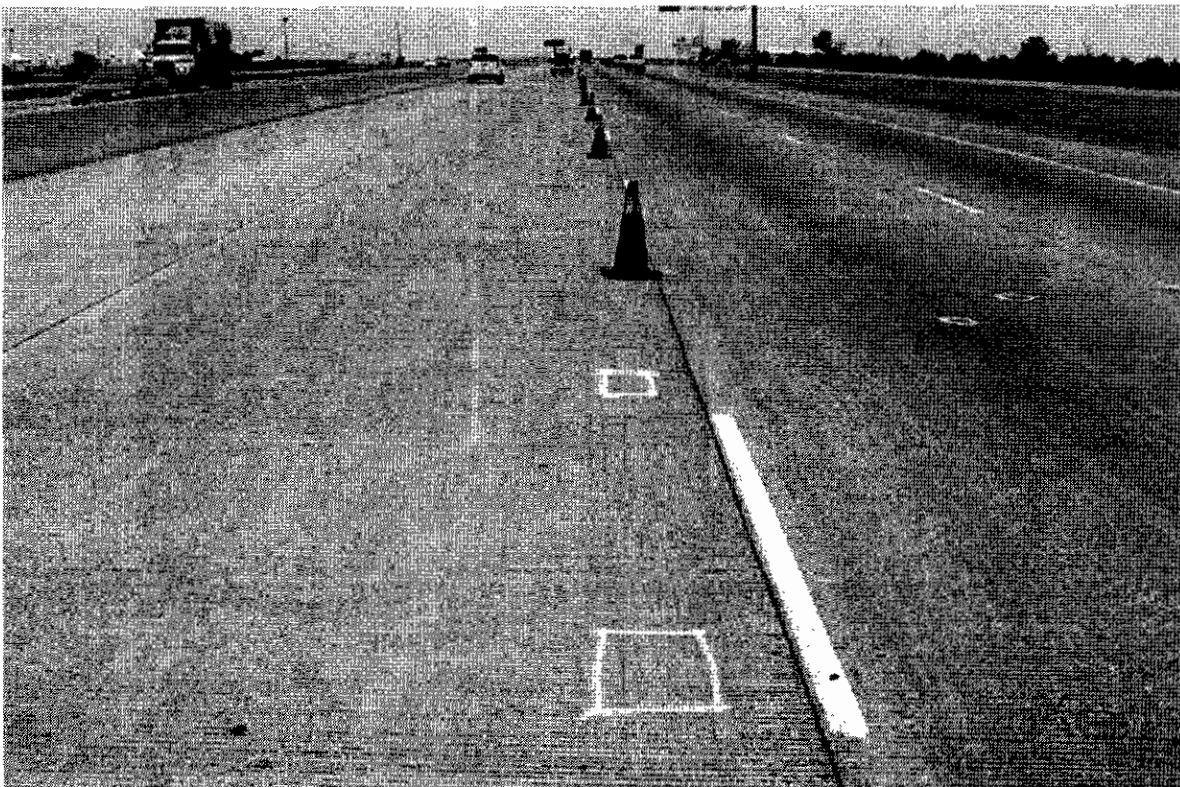
Figure 14: NTSB-093005.082.jpg

7. At least 60 to 100 feet prior to the skid mark, Subject Tire #2 most likely failed in a manner whereby the radial body ply pulled out, or un-wrapped, from around the bead in a localized area and resulted in a rapid loss of inflation pressure. During the failure and/or with subsequent tire/wheel rotations, torn pieces of the tire, particularly from the bead area, were deposited on the highway.

The highway leading to the skid mark is shown in the photo in Figure 14, taken from a vantage point approximately 120 feet prior to the skid mark. Between the first two cones in the photo, orange marking paint on the highway identifies "TIRE" in three locations in the center lane, representing where certain tire/rubber pieces were recovered by investigators. Figures 15 and 16 are closer views of the initiation of the skid mark.

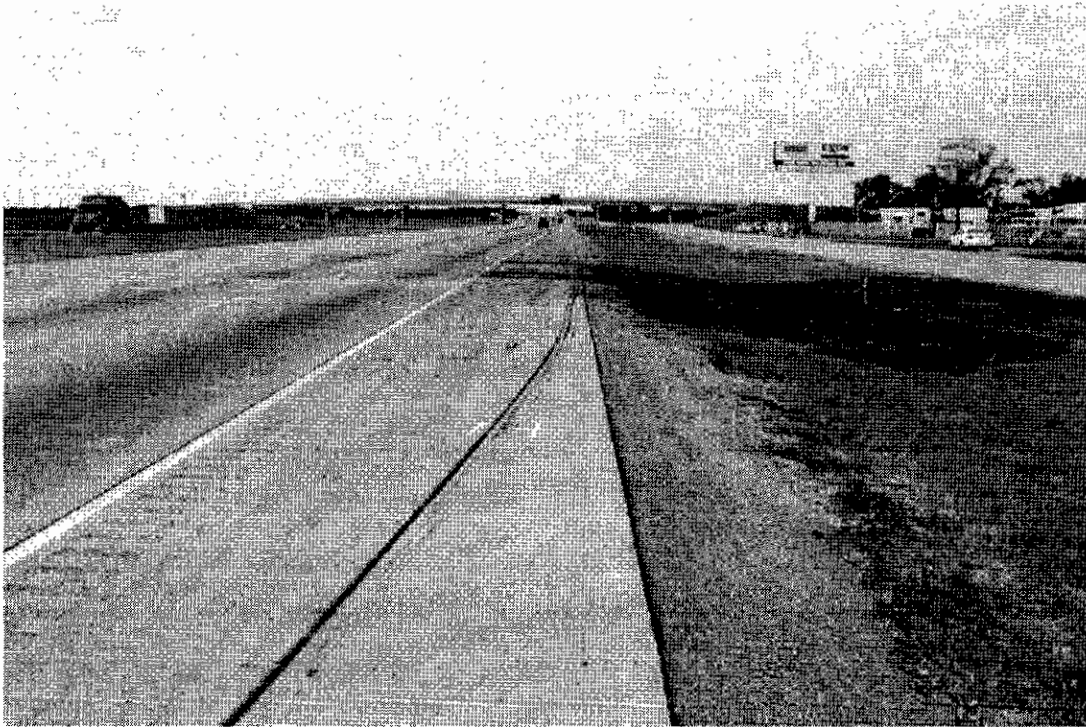
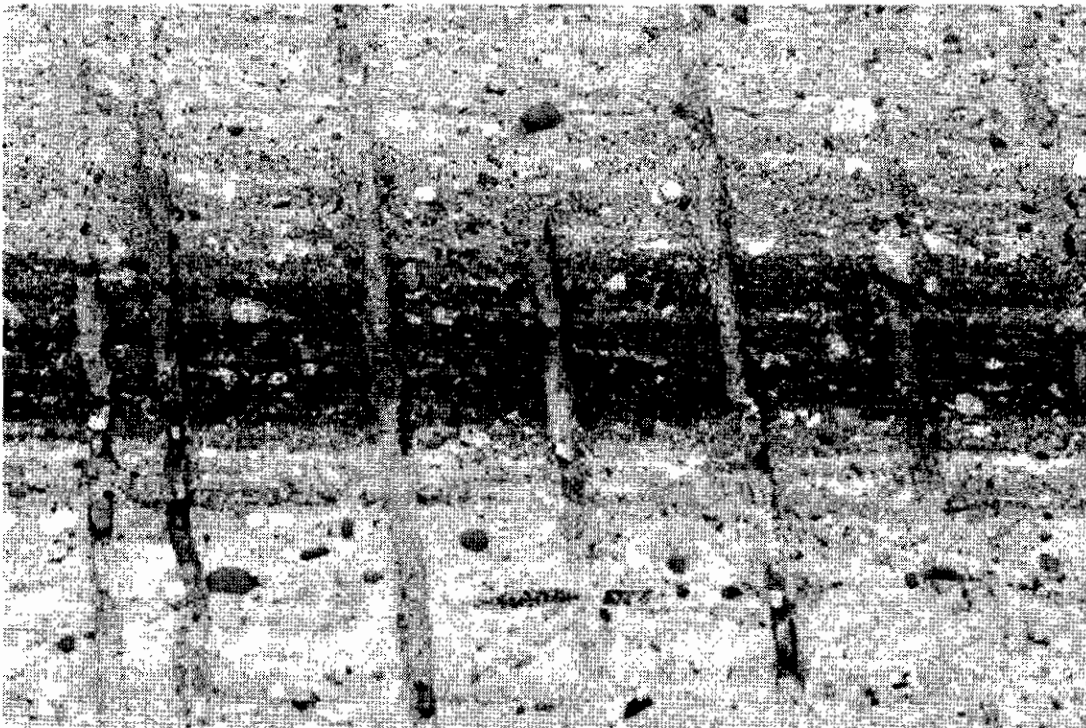
Figure 17: NTSB-092905-061.jpg

8. Ultimately, the tire and wheel initiated a lock-up condition exhibited by the skid mark, which extends for about 1,520 feet. The final portion of the skid mark and numerous tire/rubber pieces recovered from the highway exhibit soft, pliable appearance/residue consistent with excessive heat damage.

The coach ultimately crossed over the center and right lanes and came to stop on the right-most shoulder of the highway just past Exit 269. Approximately 1,520 feet of skid markings lead to this location, shown in Figure 17. A close view of the tire mark at this end, shown in Figure 18, reveals a softened, gum-like appearance.

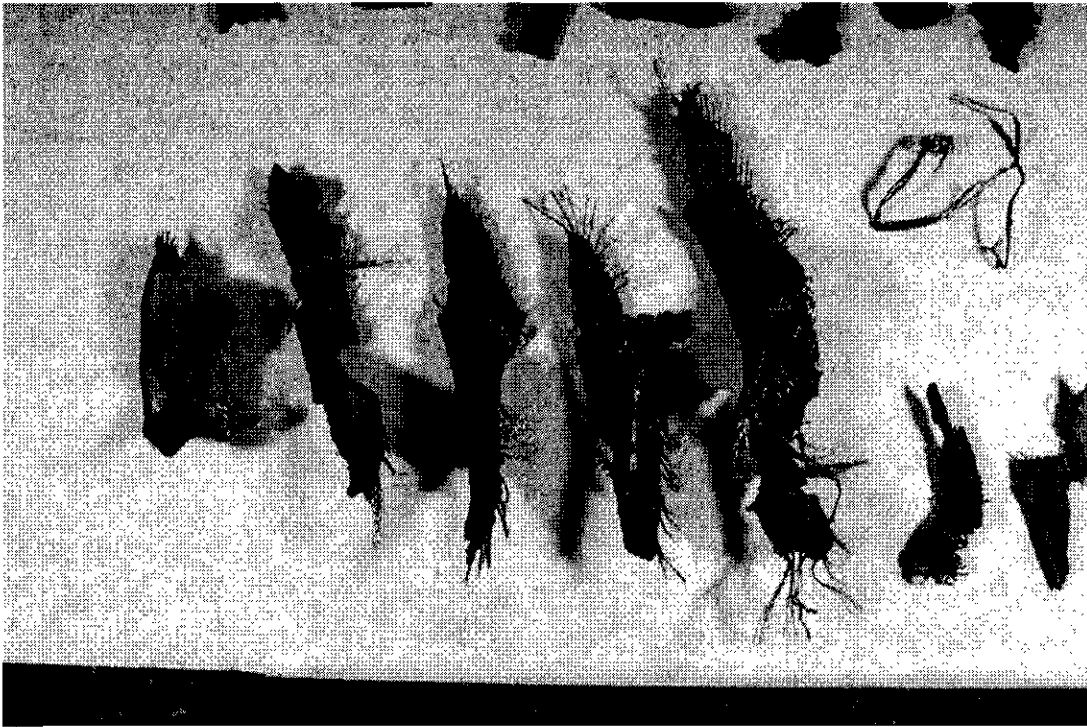
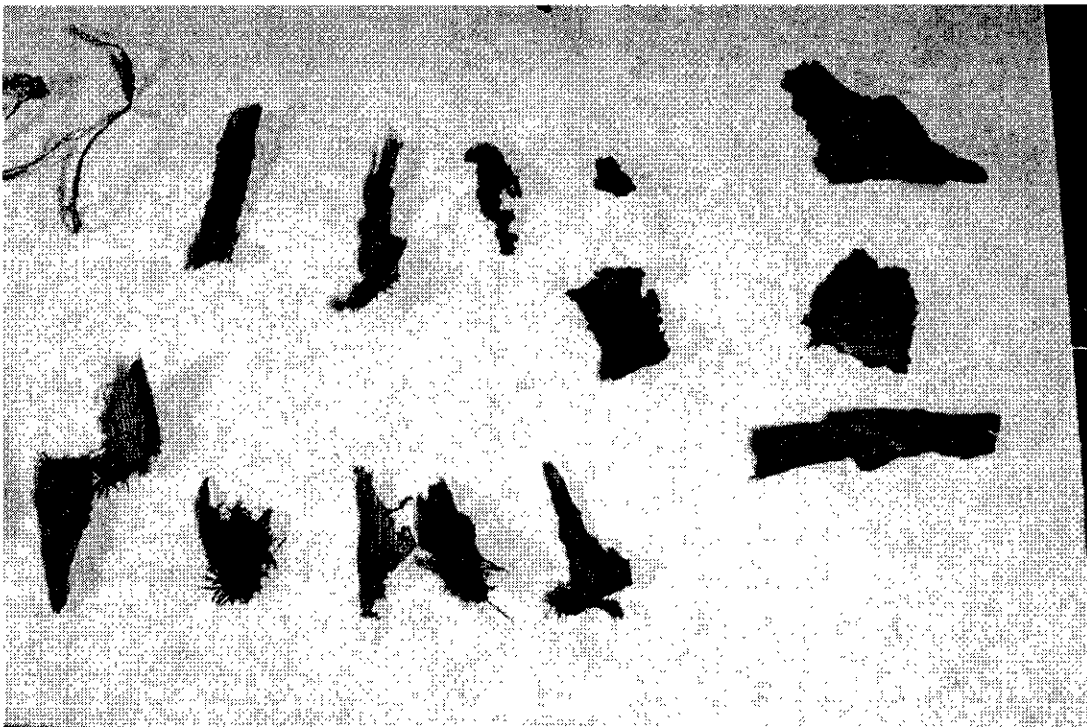
Figure 19: 051326-C002.jpg

9. Because the vast majority of Subject Tire #2 is unavailable and since the bead area pieces recovered at the scene are not consistent with design/component materials utilized by Bridgestone/Firestone-related entities, I cannot definitively identify the manufacturer, model, size, or date of production of the subject tire. Nor can most aspects of the tire's pre-accident condition be determined; for instance, it is not known whether the tire exhibited characteristics of proper care/maintenance, whether it was previously damaged, or whether there was adequate tread depth. However, none of the recovered tire pieces, albeit limited in quantity and scope, appear to exhibit any defective or unreasonably dangerous characteristics in design or manufacture.

Of the tire/rubber pieces recovered from the highway by investigators, Figure 19 shows the larger bead area pieces of Subject Tire #2 which have steel cord wrap-around bead reinforce/chafer and woven fabric bead toe reinforce/chafer. In Figure 20, numerous additional bead area pieces are shown, including pieces of a woven fabric bead flipper component.

1. Subject Tire#2: Components/materials that comprise certain bead area pieces recovered from the highway at the scene leading to the fire (i.e. Figures 19 and 20) are not consistent with those utilized by Bridgestone/Firestone or other Bridgestone- or Firestone-related entities.
2. Subject Tire #1: The tire/wheel assembly recovered from the spare tire carrier after the fire was the flat tire/wheel assembly from the right side of tag axle #3 (Figures 10-13) involved in the first incident (lock-up leading to the flat tire).

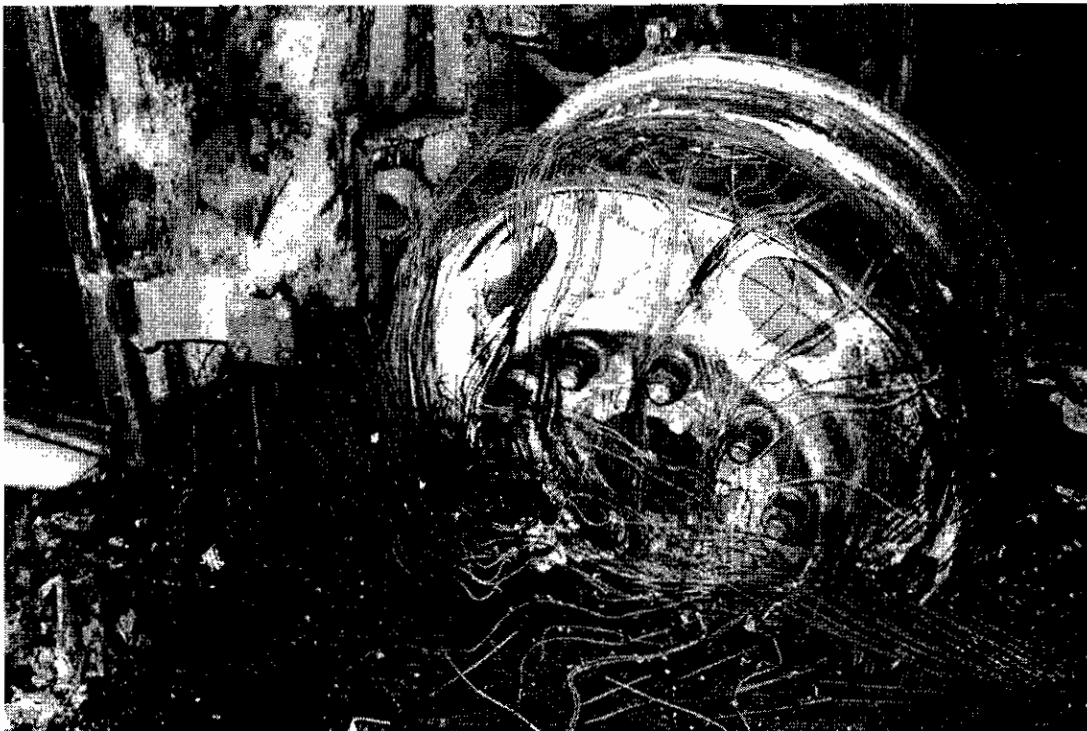
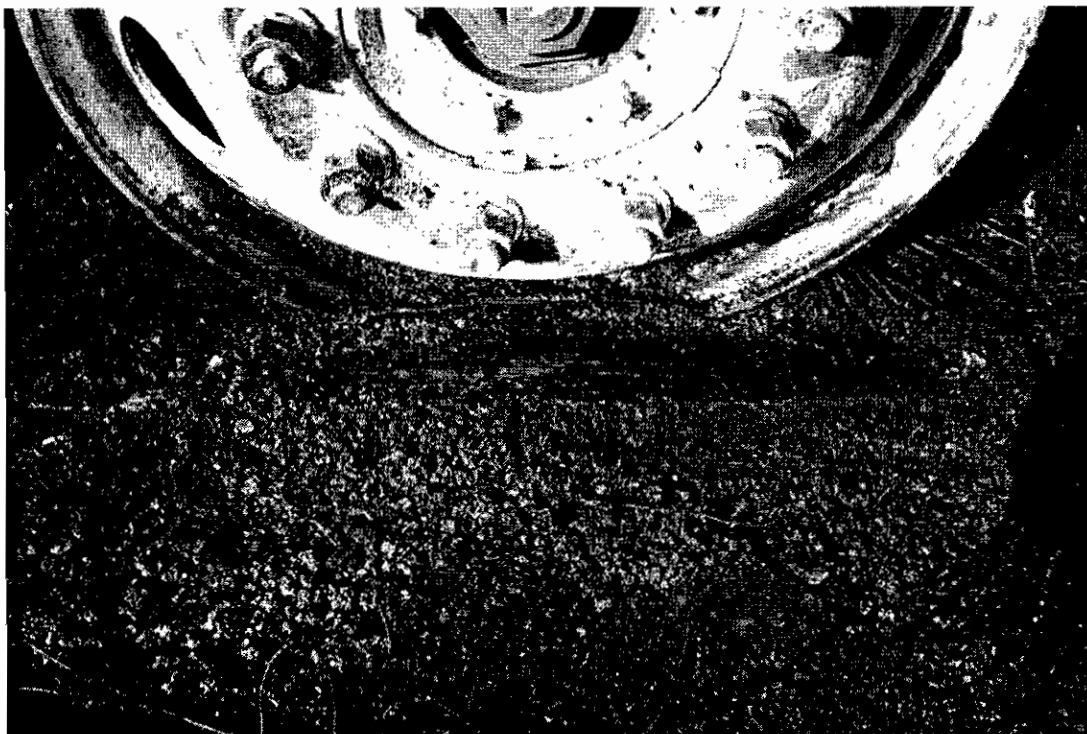
Figure 21: P0000891.jpg

5. Although Subject Tire #2, the spare tire applied to the right rear of the tag axle, was predominantly destroyed by fire, evidence indicates that prior to the fire the tire most likely failed under the stress and strain of cyclic deflection with increasing inflation pressure and excessive application of heat—with resulting damage—to the tire casing.

After the fire was extinguished, the tire/wheel on the right side of axle #3 (Subject Tire/Wheel Assembly #2) had an appearance as shown in Figure 21. A closer view of the wheel contact with the road surface as it appeared after debris was removed by investigators is shown in Figure 22.

Once Subject Tire #2 was deflated and entered the lock-up condition, more of the tire became in direct contact with, or more proximate to, the central portion of the wheel/hub assembly. Contact with, or close proximity to, a heat source could cause the tire to ignite, given sufficient time and temperature among other factors.
